AGARD CONFERENCE PROCEEDINGS 565

Corrosion Detection and Management of Advanced Airframe Materials

*Papers presented at the 79th Meeting of the AGARD Structures and Materials Panel, held in
Seville, Spain, 5-6 October 1994.*

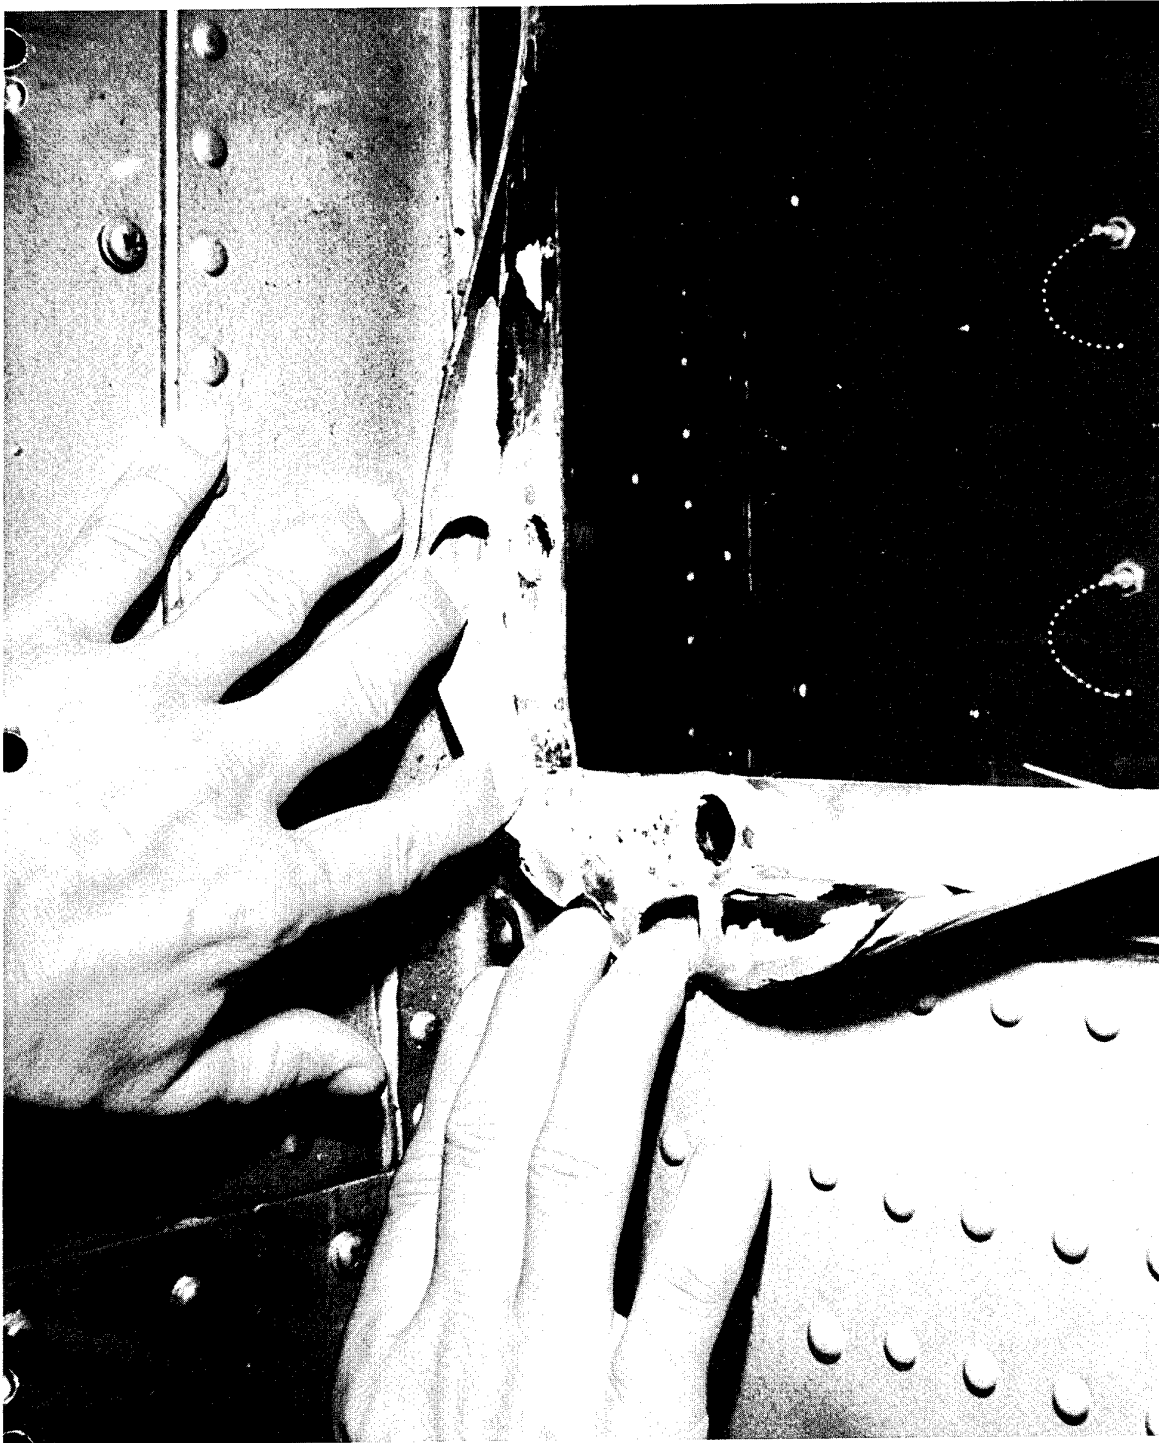
- SH-60F LH Avionics Access Door Gasket Corrosion .
Typical of Corrosion Seen Under Other EMI Conductive Gaskets

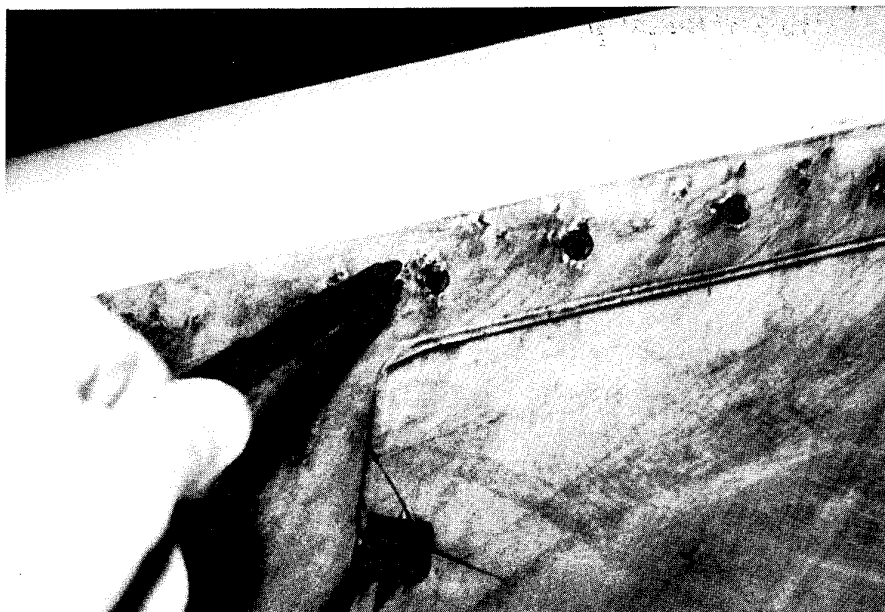
MR TIP CAP CORROSION ADJACENT TO ATTACHMENT SCREW
